Expedient MESL Construction in Cold Weather

Jeffrey A. Stark, Rosa T. Affleck, and Sherri A. Orchino

Technical Report
ERDC/CRREL TR-00-8

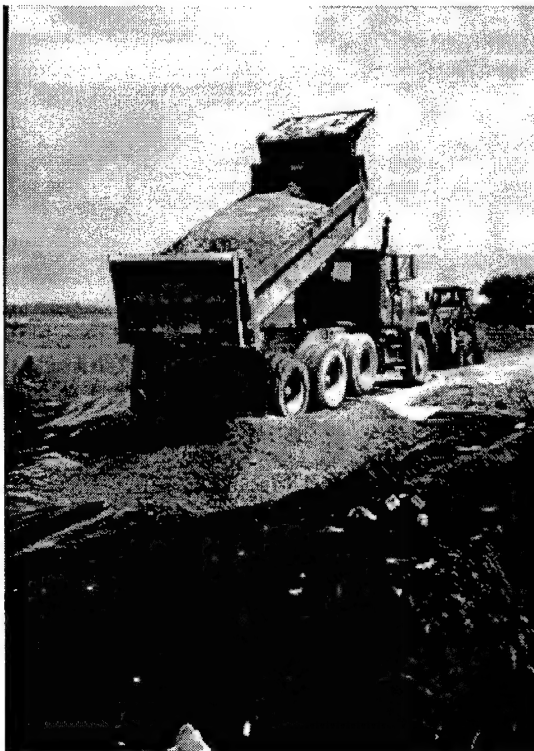
Figure 5. Using a D-7 to spread soil in the MESL.

The fill material was transported to the site in 20-ton dump trucks. Because vehicle traffic would damage the membranes, the trucks had to back to the edge of the excavation to dump the fill soil (Fig. 4) and a dozer pushed the material over the membrane (Fig. 5). A loaded 20-ton dump

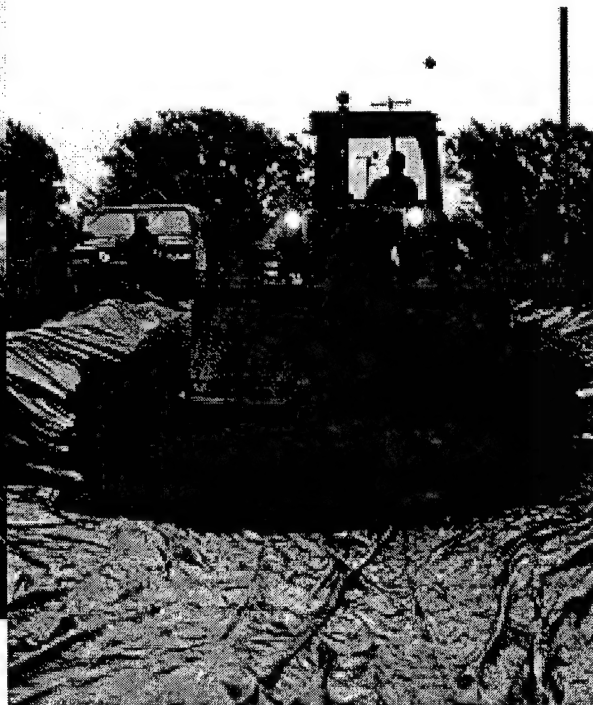
Figure 6. Taping the lower membrane; the upper membrane is being cleaned.

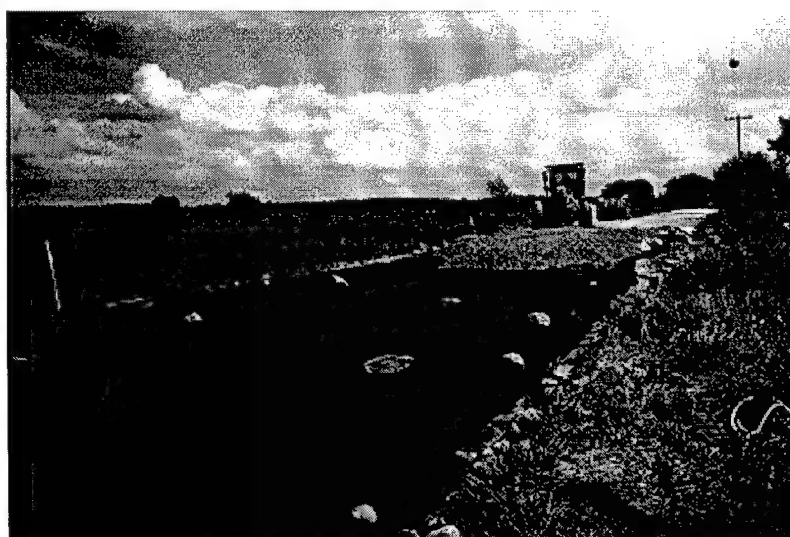
Figure 7. Spreading the gravel wearing course on the MESL.

The gravel for the wearing surface was brought to the site in 20-ton dump trucks. Once again the trucks had to back to the edge of the MESL to dump the gravel to avoid damaging the membrane. The D-7 dozer and a bucket loader were used to spread the gravel over the MESL. On the final day of construction a grader was brought from another construction site to spread the gravel to a 152-mm (6-in.) lift (Fig. 7). The gravel was compacted by vehicle traffic.

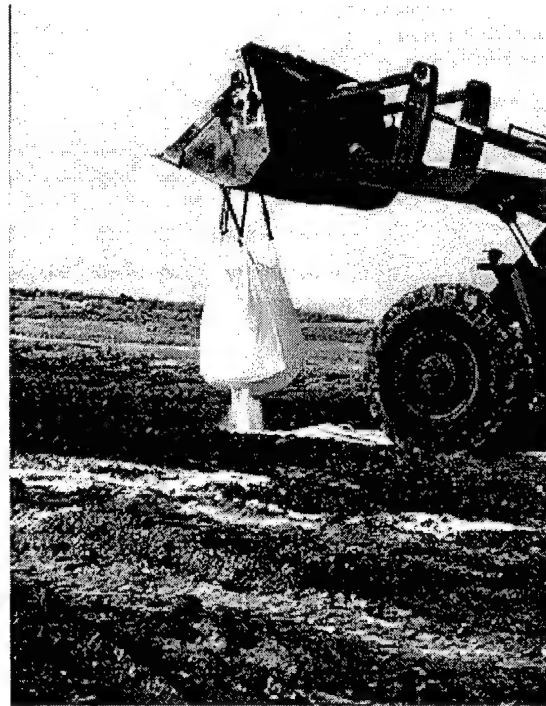
Figure 8. Bucket loader spreading lime.

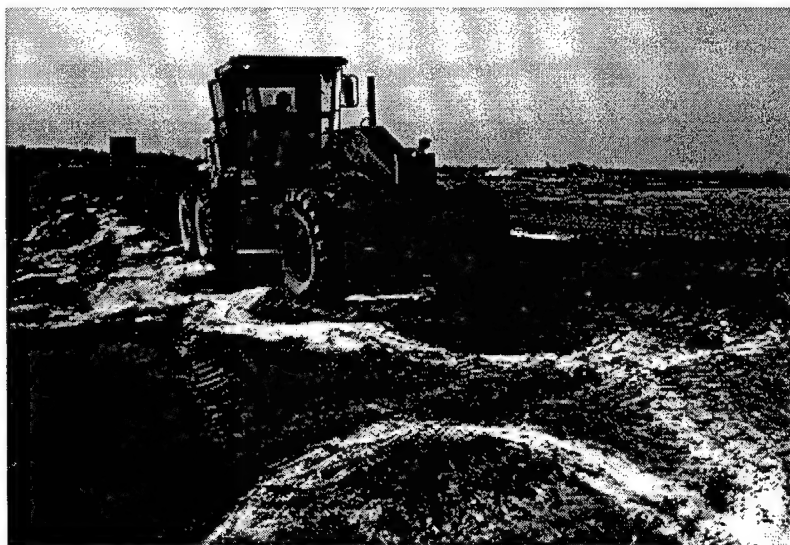
Figure 9. Grader mixing soil and lime.

The scarifying teeth of a grader were used to mix lime into the soil to a depth of approximately 102 mm (4 in.) (Fig. 9); the soil also was bladed. Water was added several times until there was enough moisture for compaction.

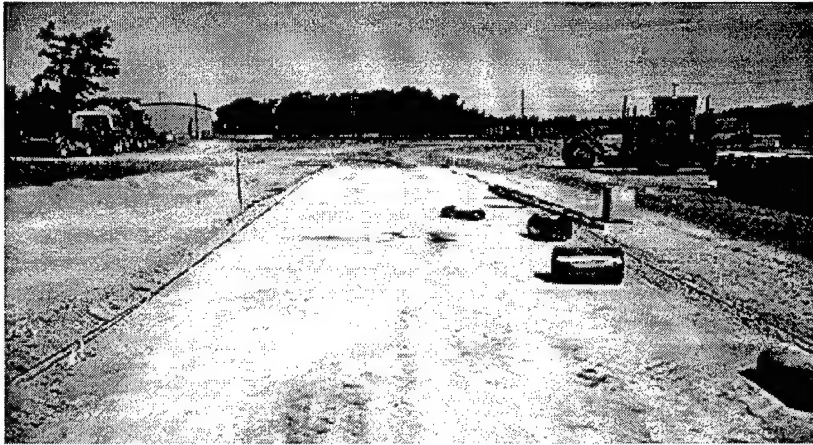
Figure 10. Compacted clay layer used to simulate the top of a MESL.

pan. These trenches provided an area to wash the gravel into when the test was completed. Next, six inches of clay was placed on the test section. Water was added to the clay, scarified, and compacted to simulate the top of a finished MESL, prior to placement of the upper membrane (Fig. 10).

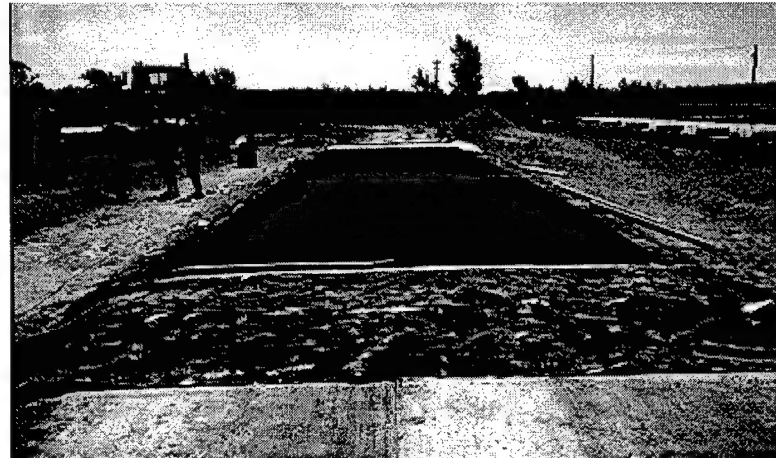
Figure 11. Completed puncture test section before placing a wearing surface.

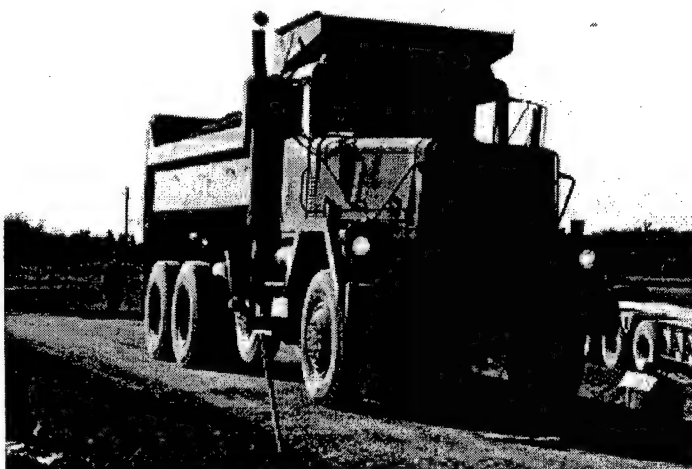
Figure 14. Trafficking the puncture test.

The test section was trafficked with a loaded 20-ton dump truck for 170 passes (Fig. 14). The truck made a loop to traffic and traveled at approximately 10 mph on the test section. The truck also followed approximately the same path each time, simulating a worst-case scenario.

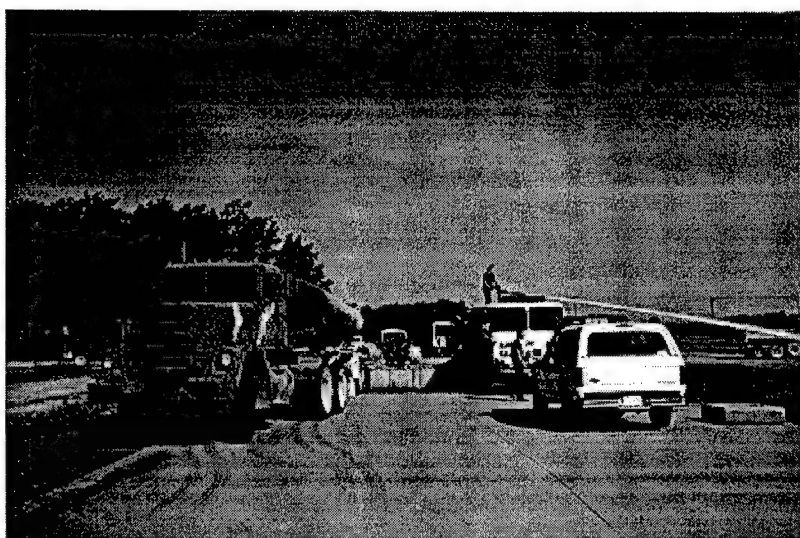
Figure 15. Equipment used to wash gravel off the test section.

After trafficking, the gravel was removed to observe any membrane damage. A grader removed the top few inches of gravel from the test section. The Fort Drum Fire Department then used one of its fire trucks to remove the rest (Fig. 15 and 16). This procedure worked well and mini-

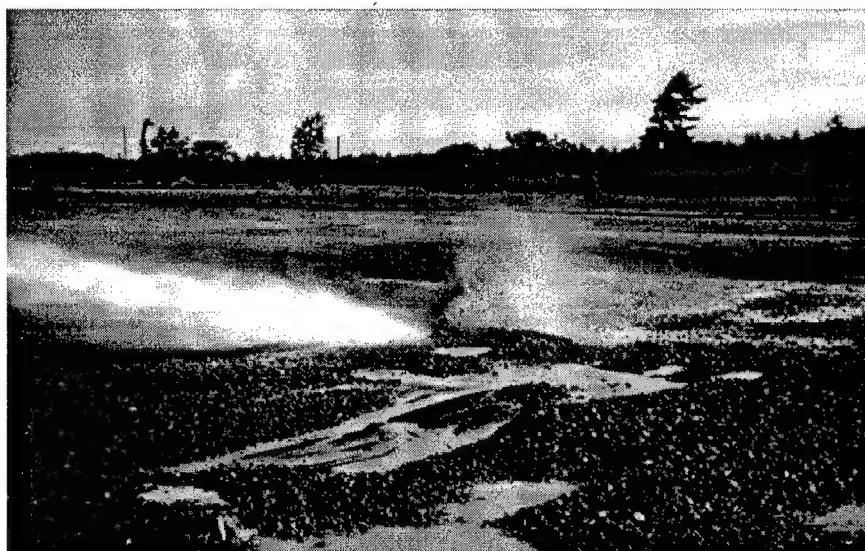
Figure 16. Washing gravel.

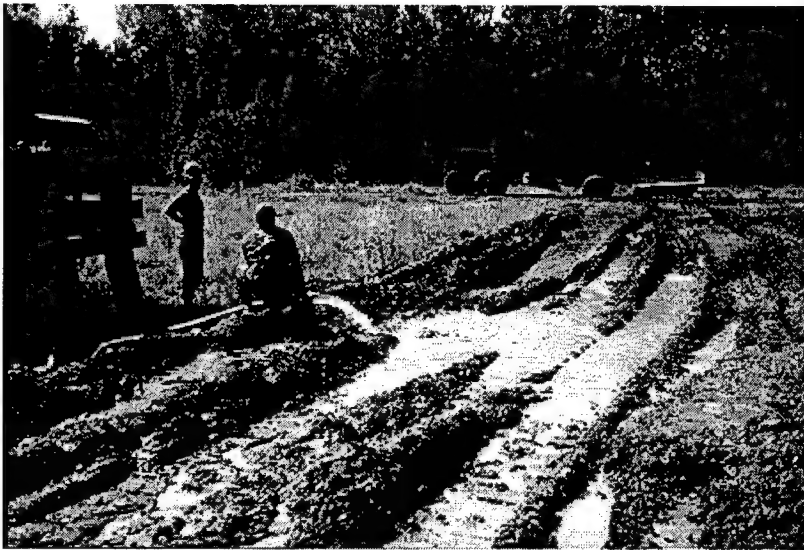
Figure 17. Adding water to the absorbent test section at Ethan Allen Firing Range, Vermont.

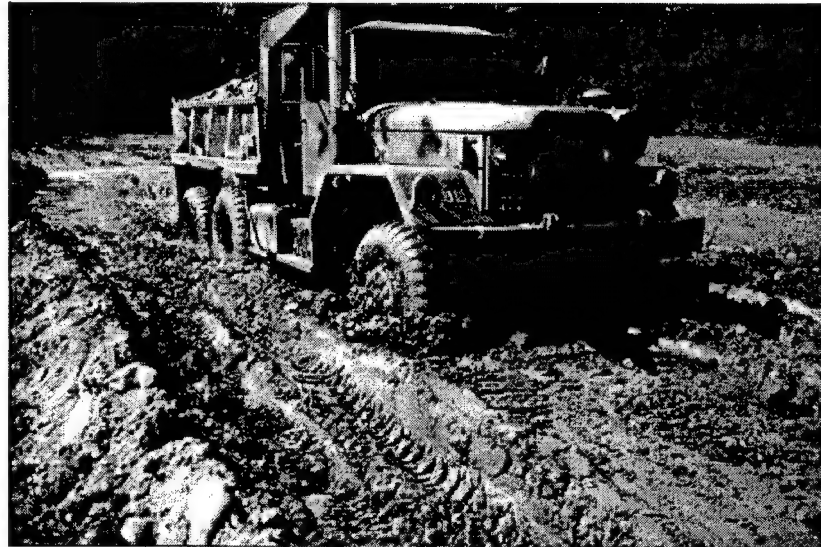
Figure 18. Trafficking the absorbent test section.

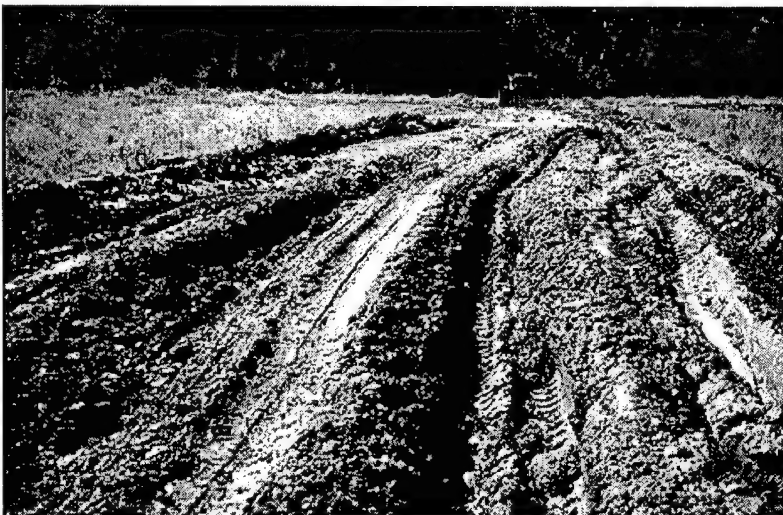
Figure 19. Wheel ruts after one pass.

The test site was an old gravel pit. Because of the low quality of the gravel (due to a high fines content), it was typically used as a fill material at least 0.61 m (2 ft) below the road surface. A thin organic layer had formed on the gravel and supported grass growth. A test section approximately 4.57 m (15 ft) wide by 130 m (100 ft) long was prepared for the test. The existing material was mixed together using a dozer, and additional silty sand was added. Water was added to make the soil muddy (Fig. 17). The wet layer was approximately 305 mm (1 ft) deep with a solid layer underneath. When trafficked, a 5-ton truck (Fig. 18) would sink to the hard layer, and in some places the soil was too weak to maintain the wheel ruts (Fig. 19).

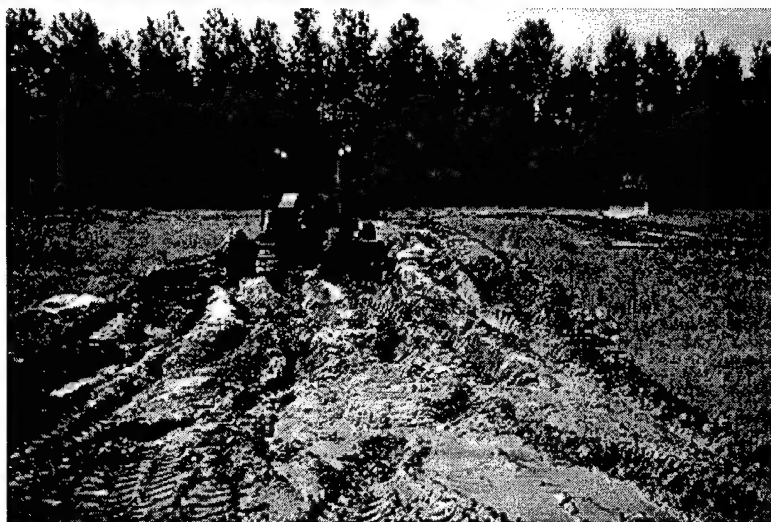
Figure 21. Mixing absorbent and soil together.

Next, 136 kg (300 lb) of the absorbent was added (Fig. 20) and mixed with a grader (Fig. 21). The grader trafficked only the test section and did not use its blade or scarifying teeth to mix the soil and absorbent. After mixing, a dozer was used to back-blade the test section and provide a smooth surface. The center of the section was dryer than the ends. This was due to standing water before the absorbent was added at the far end of the test section and not enough absorbent being added to the near end of the test section.

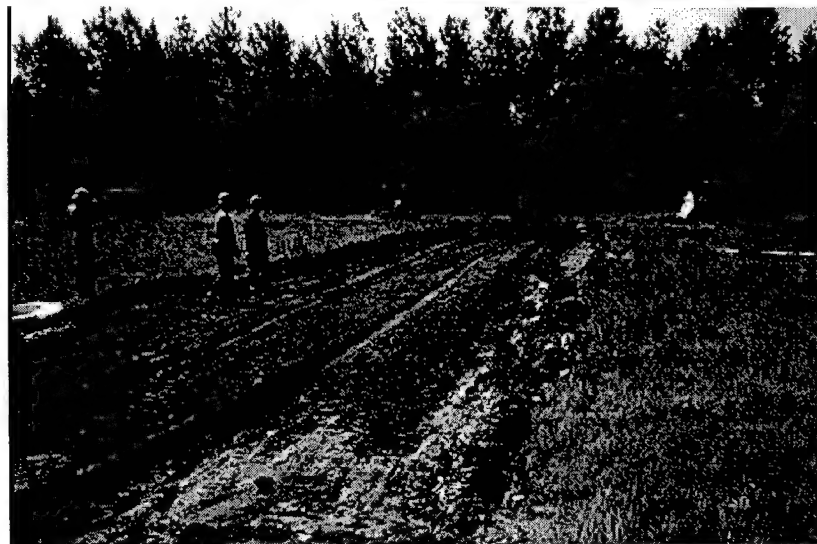
Figure 22. Test section after one pass with a CUCV.

A Commercial Utility and Cargo Vehicle (CUCV) was driven across the test section leaving approximately 51-mm- (2-in.-) deep ruts in the center of the section and 152-mm (6-in.) ruts on either end (Fig. 22). The CUCV was able to drive through the test section in 2-wheel drive when

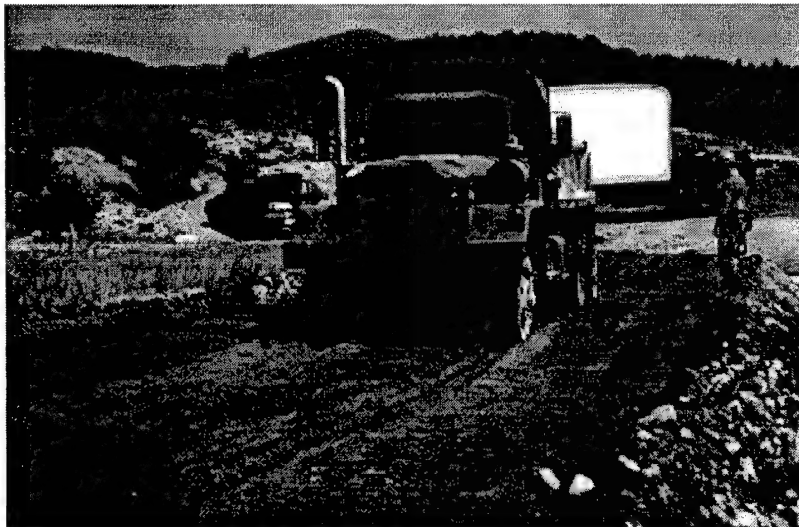
Figure 23. Trafficking the section with a 5-ton dump truck.

the test section would have been impassable in 4-wheel drive before treatment. A loaded 5-ton dump truck was then driven through the test section (Fig. 23 and 24). It left approximately 102-mm- (4-in.-) deep ruts in the center and 203-mm- (8-in.-) deep ruts on either end. The 5-ton dump truck then trafficked the section 30 times and left 178- to 279-mm- (7- to 11-in.-) deep ruts in the center and far end and 356-mm- (14-in.-) deep ruts at the near end (Fig. 25). The rutting was not caused by the soil being too "wet" but the result of a lack of cohesion. At the end of the test the soil looked dry and friable. The average water content of the top 76 mm (3 in.) of soil was 17.8%. Its grain size distribution was not determined. The cone penetrometer test results were not valid because the cone hit the larger gravel pieces.

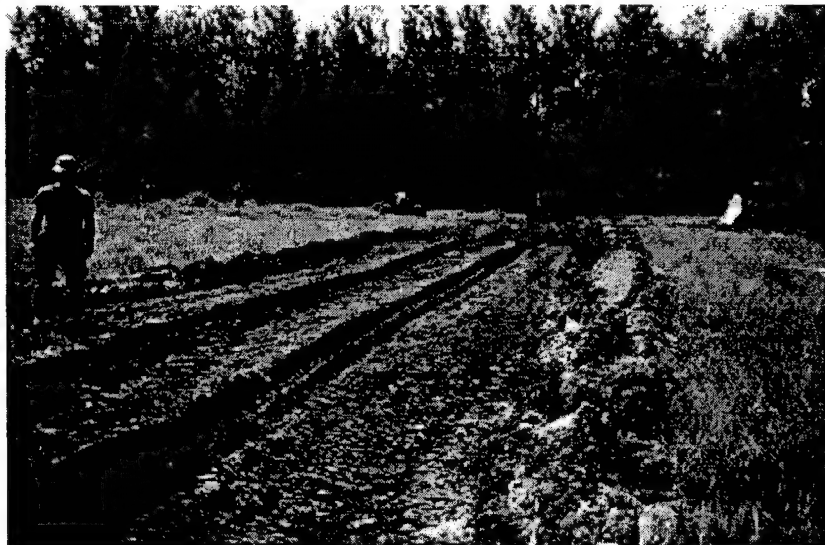
Figure 24. Test section after one pass with a 5-ton dump truck.

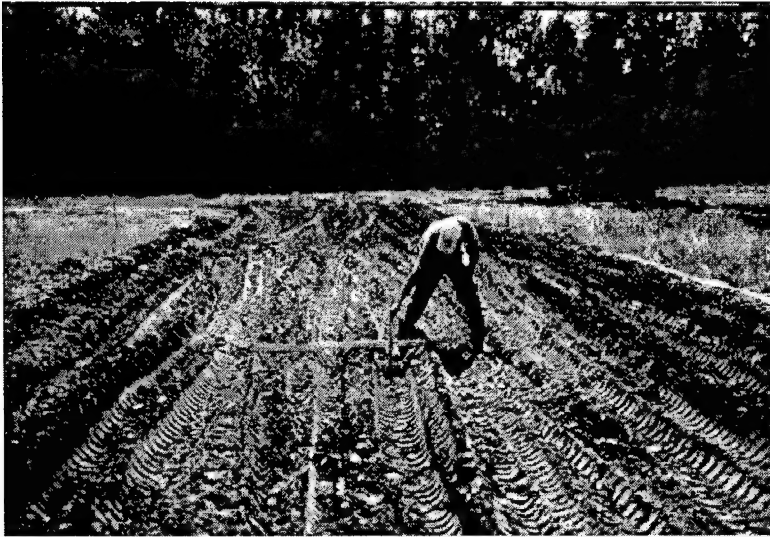
Figure 25. Test section after 30 passes with a 5-ton dump truck.

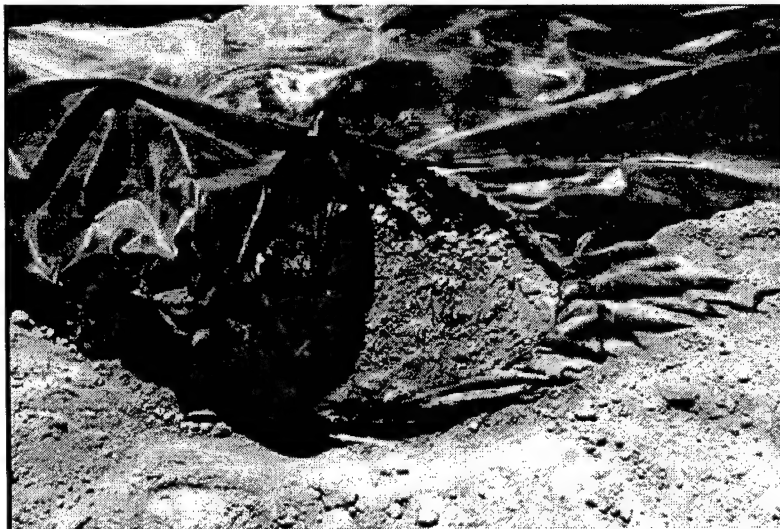
Figure 27. Membrane tear.

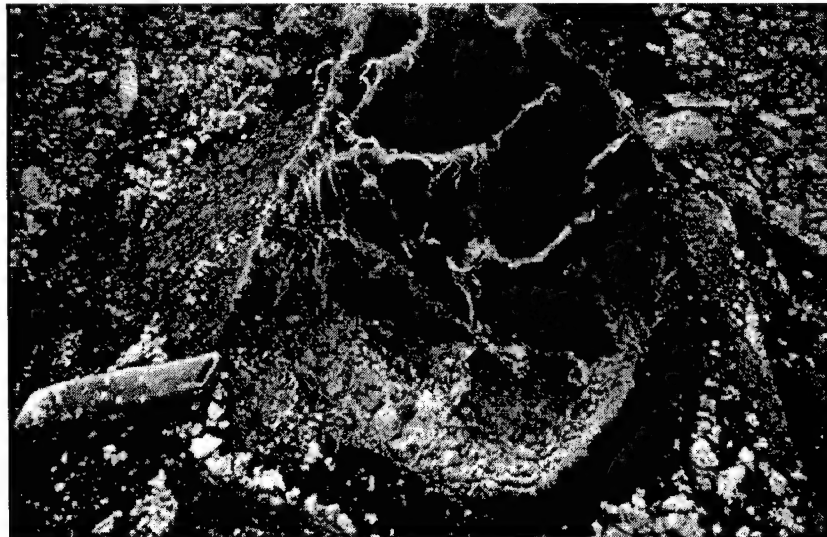
Figure 28. Top-membrane tear, caused by a bucket loader.

Placing the wearing course. A 152-mm (6-in.) gravel wearing course was used. It was difficult to place a uniform thickness of gravel because the surface of the MESL was not level. Care is still needed when spreading the gravel. A bucket loader caught the top of the MESL when spreading the gravel (Fig. 28).
